Technical Report

AQUANAUTS COMPOSITE LIFE SUPPORT

UMBILICALS—SEALAB III

Technical Report R-688

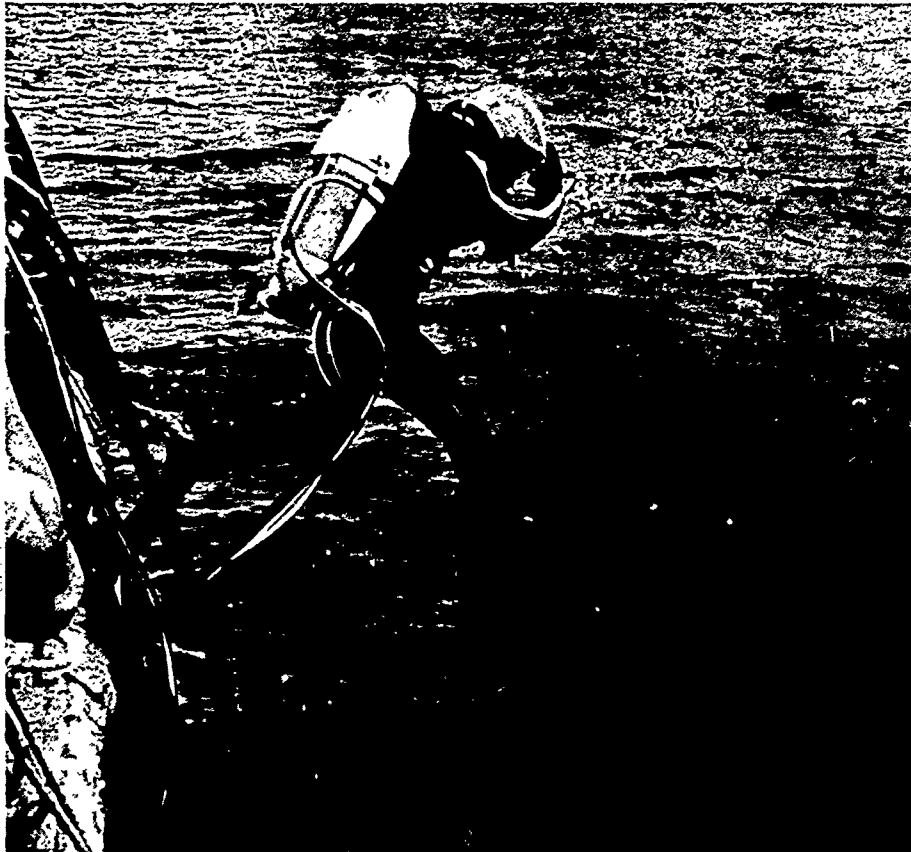
Figure.17: Diver rigged with deep-diving gear including umbilical.

A requirement existed for aquanaut life support umbilicals (Figure 16) to fulfill the life support requirements of a man utilizing an open-circuit hot water heated diver's wet suit (Figure 17) while conducting in-water work assignments. Such assignments may be performed when based either in an ocean bottom habitat under saturated conditions or conducted from a diving bell (personnel transfer capsule) and utilizing the "bounce" dive of saturated techniques. These have been designated as secondary umbilicals (Figure 18).

The concept of using secondary umbilicals requires that they be bundled with, or married to, the diver's heating-water-supply hose and the diver's breathing-gas hose shown in Figure 17. Secondary umbilical functional requirements are limited to transmitting electrical signals and power between the diver's base of operations and diver mounted life support equipment.

gas hoses are to be provided for those occasions when the divers will utilize the secondary electrical umbilicals which do not incorporate gas hose. These separate gas hoses will be married to the secondary umbilicals, together with an open-circuit, hot water diver's heating hose (Figure 17). Separate 50-foot-long jumper gas hoses will be provided for use with the modified second generation primary umbilicals. These jumpers are required to interface between the gas hose connection outside the habitat diver's station and pass into the diver's station to mate with the gas hose breakout on the habitat end of the modified umbilical. Further details regarding the reasons for this arrangement have been discussed in the report section dealing with the modified second generation primary umbilicals.

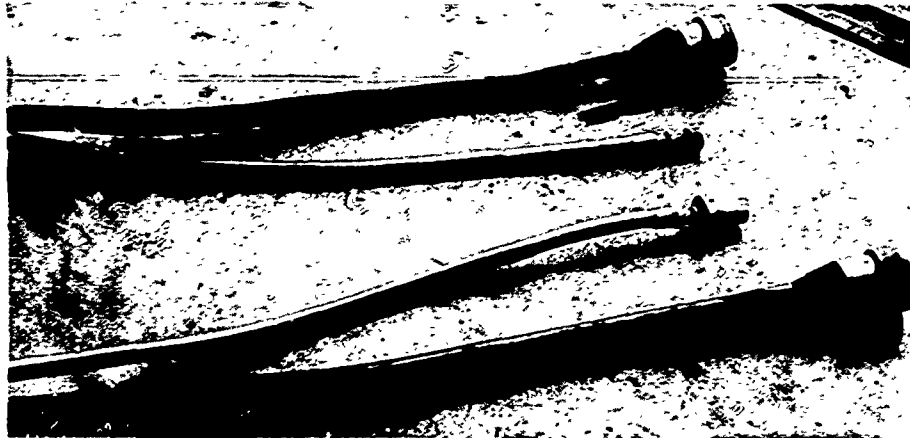
Figure 20. Breathing-gas hose of composite umbilicals (center hoses).

Each primary diver's umbilical incorporates a gas hose (Figure 20) to provide the principal means for supplying the diver's mixed breathing gas (Helium-oxygen). The diver's Mark VIII backpack breathing apparatus only provides for an emergency situation and for only a very limited time. Separate
